Manhole Inspection Summary

Manhole # S29AA1023MH

Insp Date: **12/11/06 10:38 AM**

Location Address: **3519 KESWICK RD**

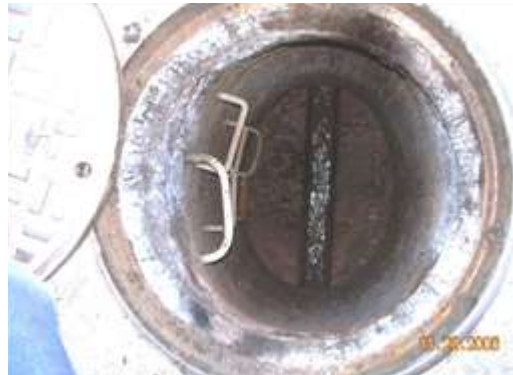
Top View

Corroded steps. Evidence of surcharge - Bench debris.

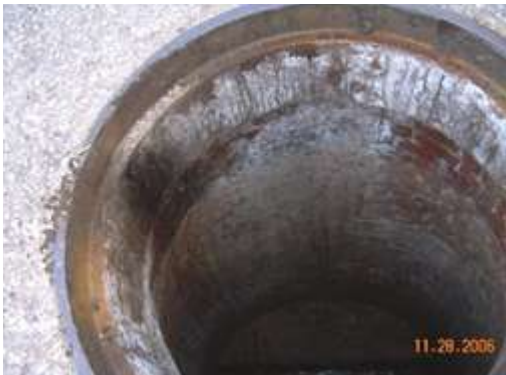
Defect

Frame leaks. Adjustment, Corbel and Barrel infiltration.

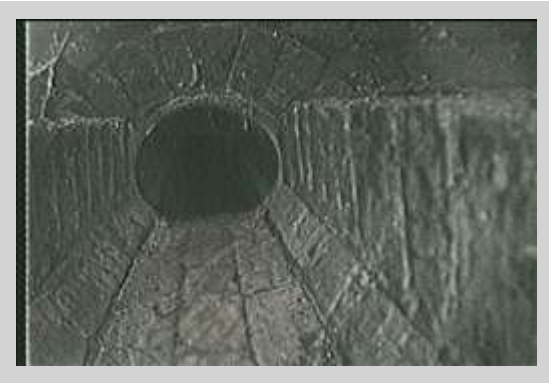
Pipe Out @ 12 O'Clock

Barrel deterioration and infiltration. Channel debris.

Infiltration: **Evidence** Pipe Seal Cond: **Cracked**

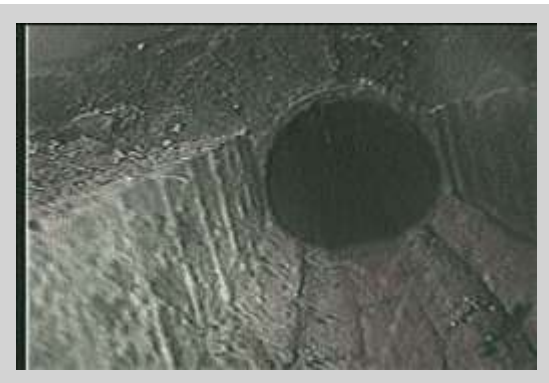
Pipe In @ 6 O'Clock

Infiltration: **Evidence** Pipe Seal Cond: **Cracked**
